Post Conflict Boundary Systems – Browns Farm, Cape Town

Michael Barry

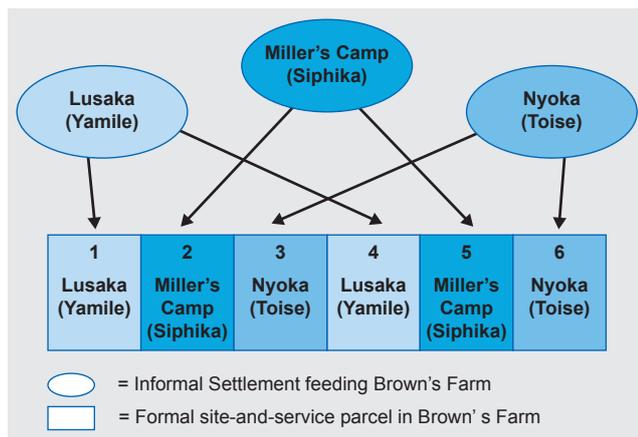
Fig. 2: Land Allocation Patterns in Browns Farm

Thus, allocating parcels in Browns Farm to three communities which may have been fighting one another was fraught with difficulties. A typical parcel in Browns Farm is between 150 m² (10 m × 15 m) and 200 m² (10 m × 20 m). When parcels were allocated, an official noted that occupants had a neighbour on each side from a different rival

faction as shown in fig. 2. This was supposedly intended to diminish the power of the warlords in mobilising their factions against people who had come from other informal settlements.

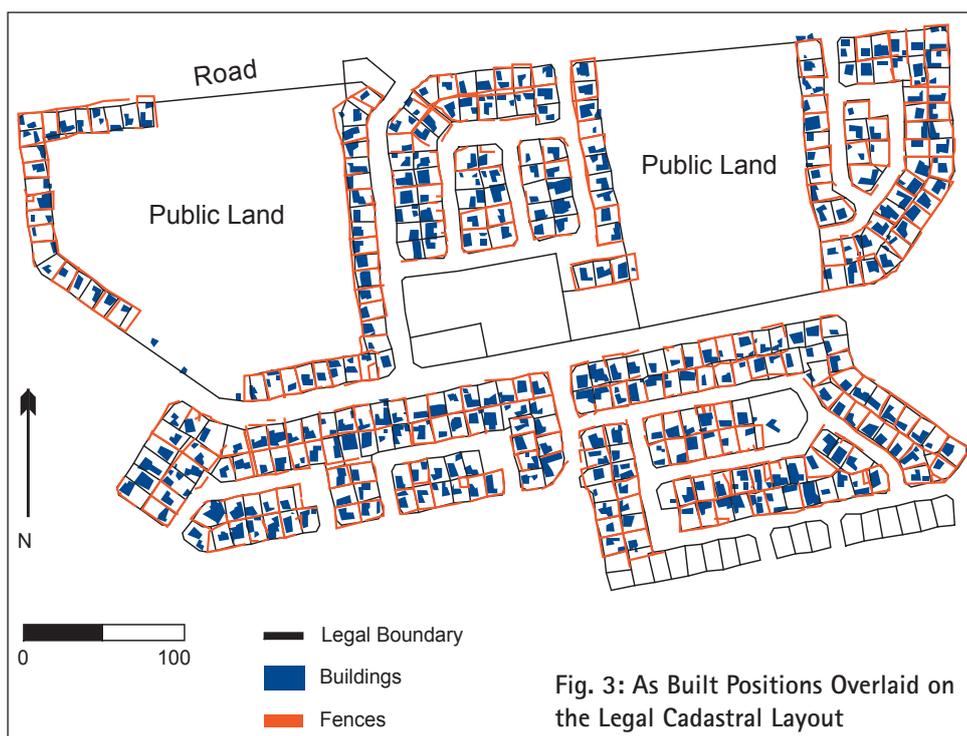
In theory 1:3.000 aerial photographs should provide a planimetric accuracy of ± 10 cm (Kraus 1994). This was obtained for points that could be considered suitable as ground control points. The RMS for the two sets of 51 points observed by the experienced operator and the author was of the order of 30 cm. Based on this and comparisons of the 1:3.000 layer and the 1:10.000 layer, if an object measured on a stereo model was found to be encroaching by more than 50 cm over the legal cadastral boundary, it was counted as an encroachment.

Allowing for some error in interpretation, some 147 of the 350 parcels (42%) were judged to have fences which encroached over their boundaries. Of these, 91 parcels had fences which encroached onto public land. Some 34 parcels (10%) were interpreted as having buildings (generally shacks) encroaching over the boundary. Of these, 20 parcels were adjudged to have shacks encroaching onto public land. Many of these latter buildings were spaza shops – small, subsistence grocery shops built on the street in front of a residence – reflecting the multi-faceted livelihoods of people in these settlements. Spaza shop structures are easily moved or dismantled if neces-

What was noticeable is that fences tended to adhere to the surveyed boundaries along the mid-block boundaries. An inspection of fig. 3 also shows that the patterns of encroachment by fences were not random, especially encroachments onto streets and other public land. One can speculate that if the first person in a block built a fence that encroached onto the street or public land, the neighbour merely tacked their fence onto this encroaching fence. The rest of the neighbours then followed suit.

Interpreting whether a fence was encroaching in an attempt by one landholder to grab land from their neighbour or if the supposedly »injured« landholder had merely built the fence within his or her boundaries proved to be difficult. After a number of different methods of interpreting the data were tested, the primary criteria for counting an encroachment was whether the position of a fence or dwelling might lead to a dispute in the long run.
